CHADWICK LAKES

Basic information on the current situation and problems

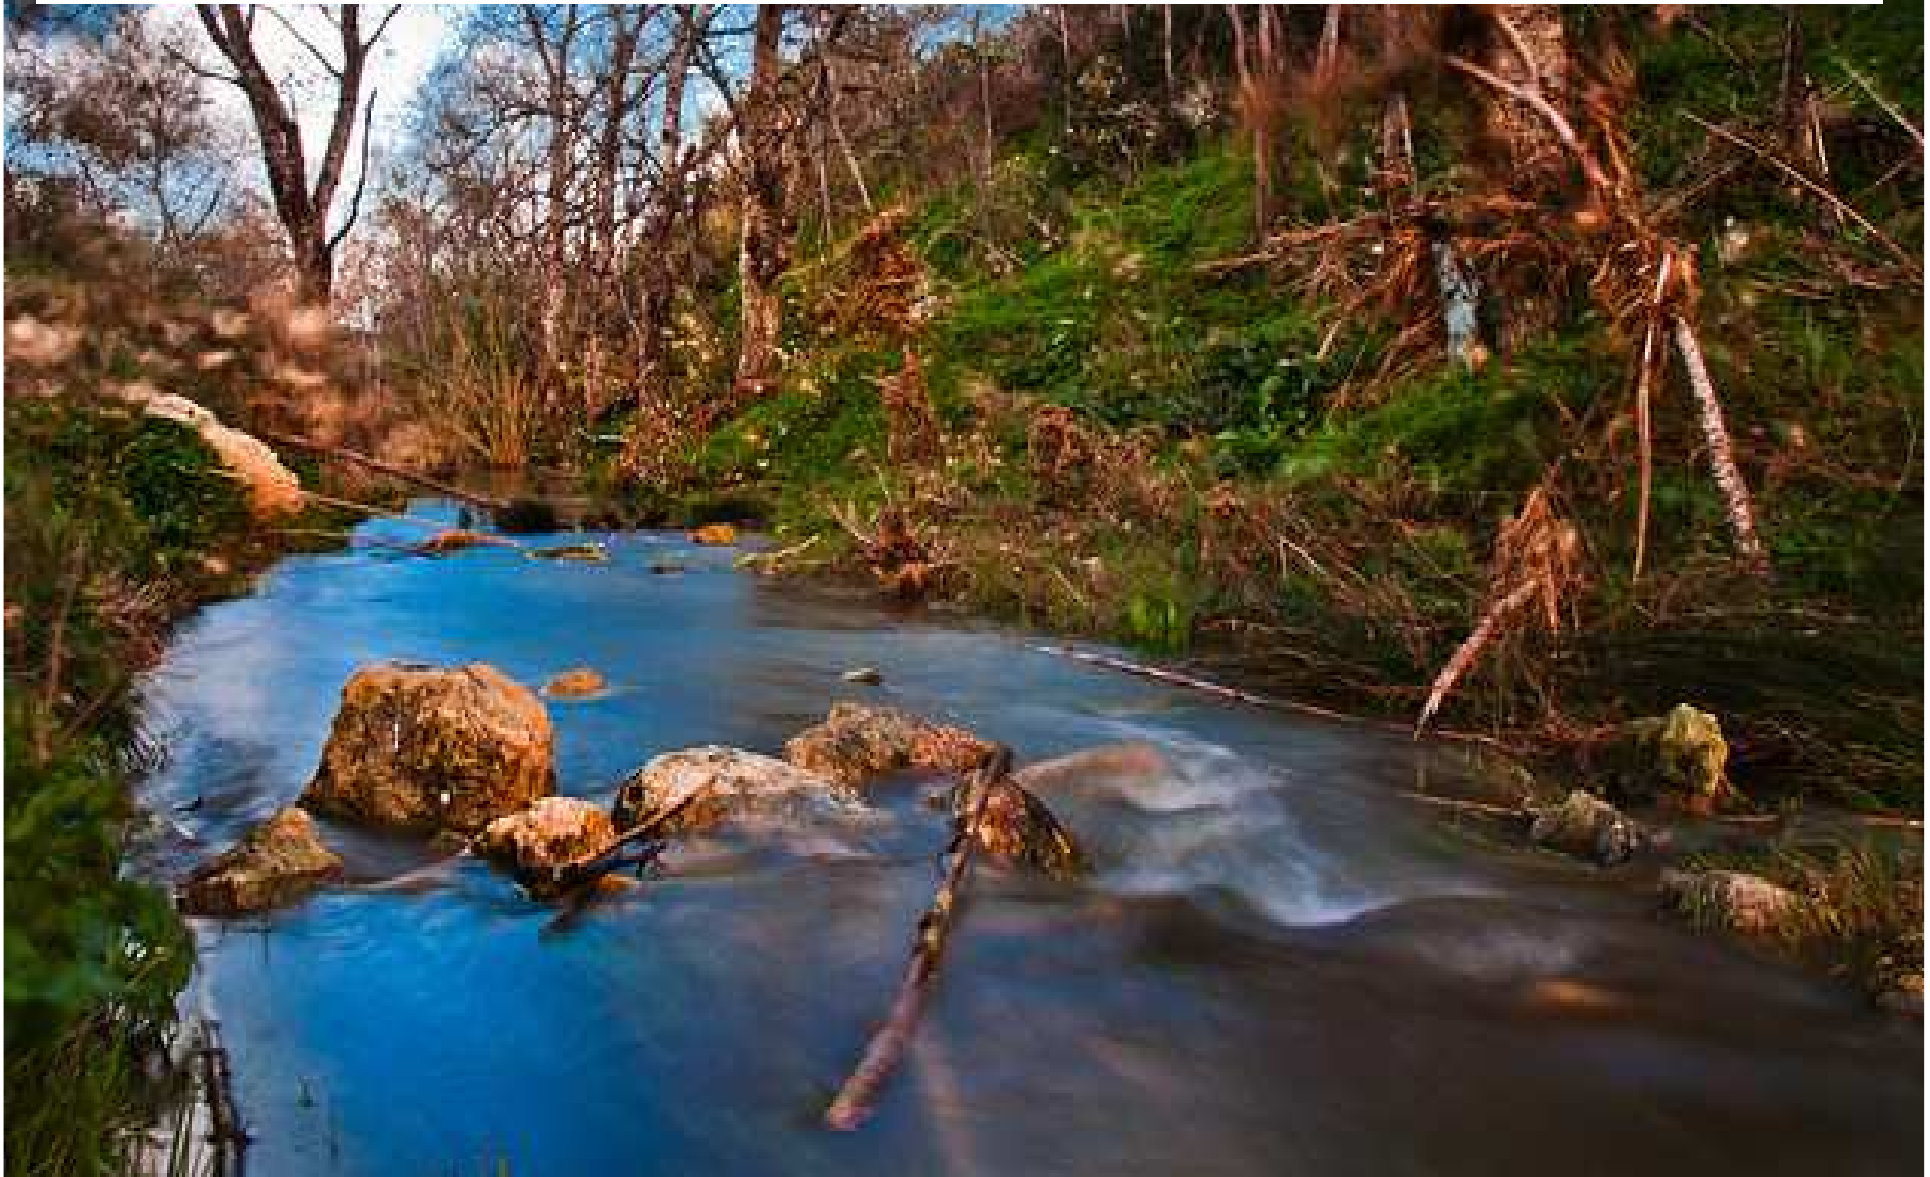
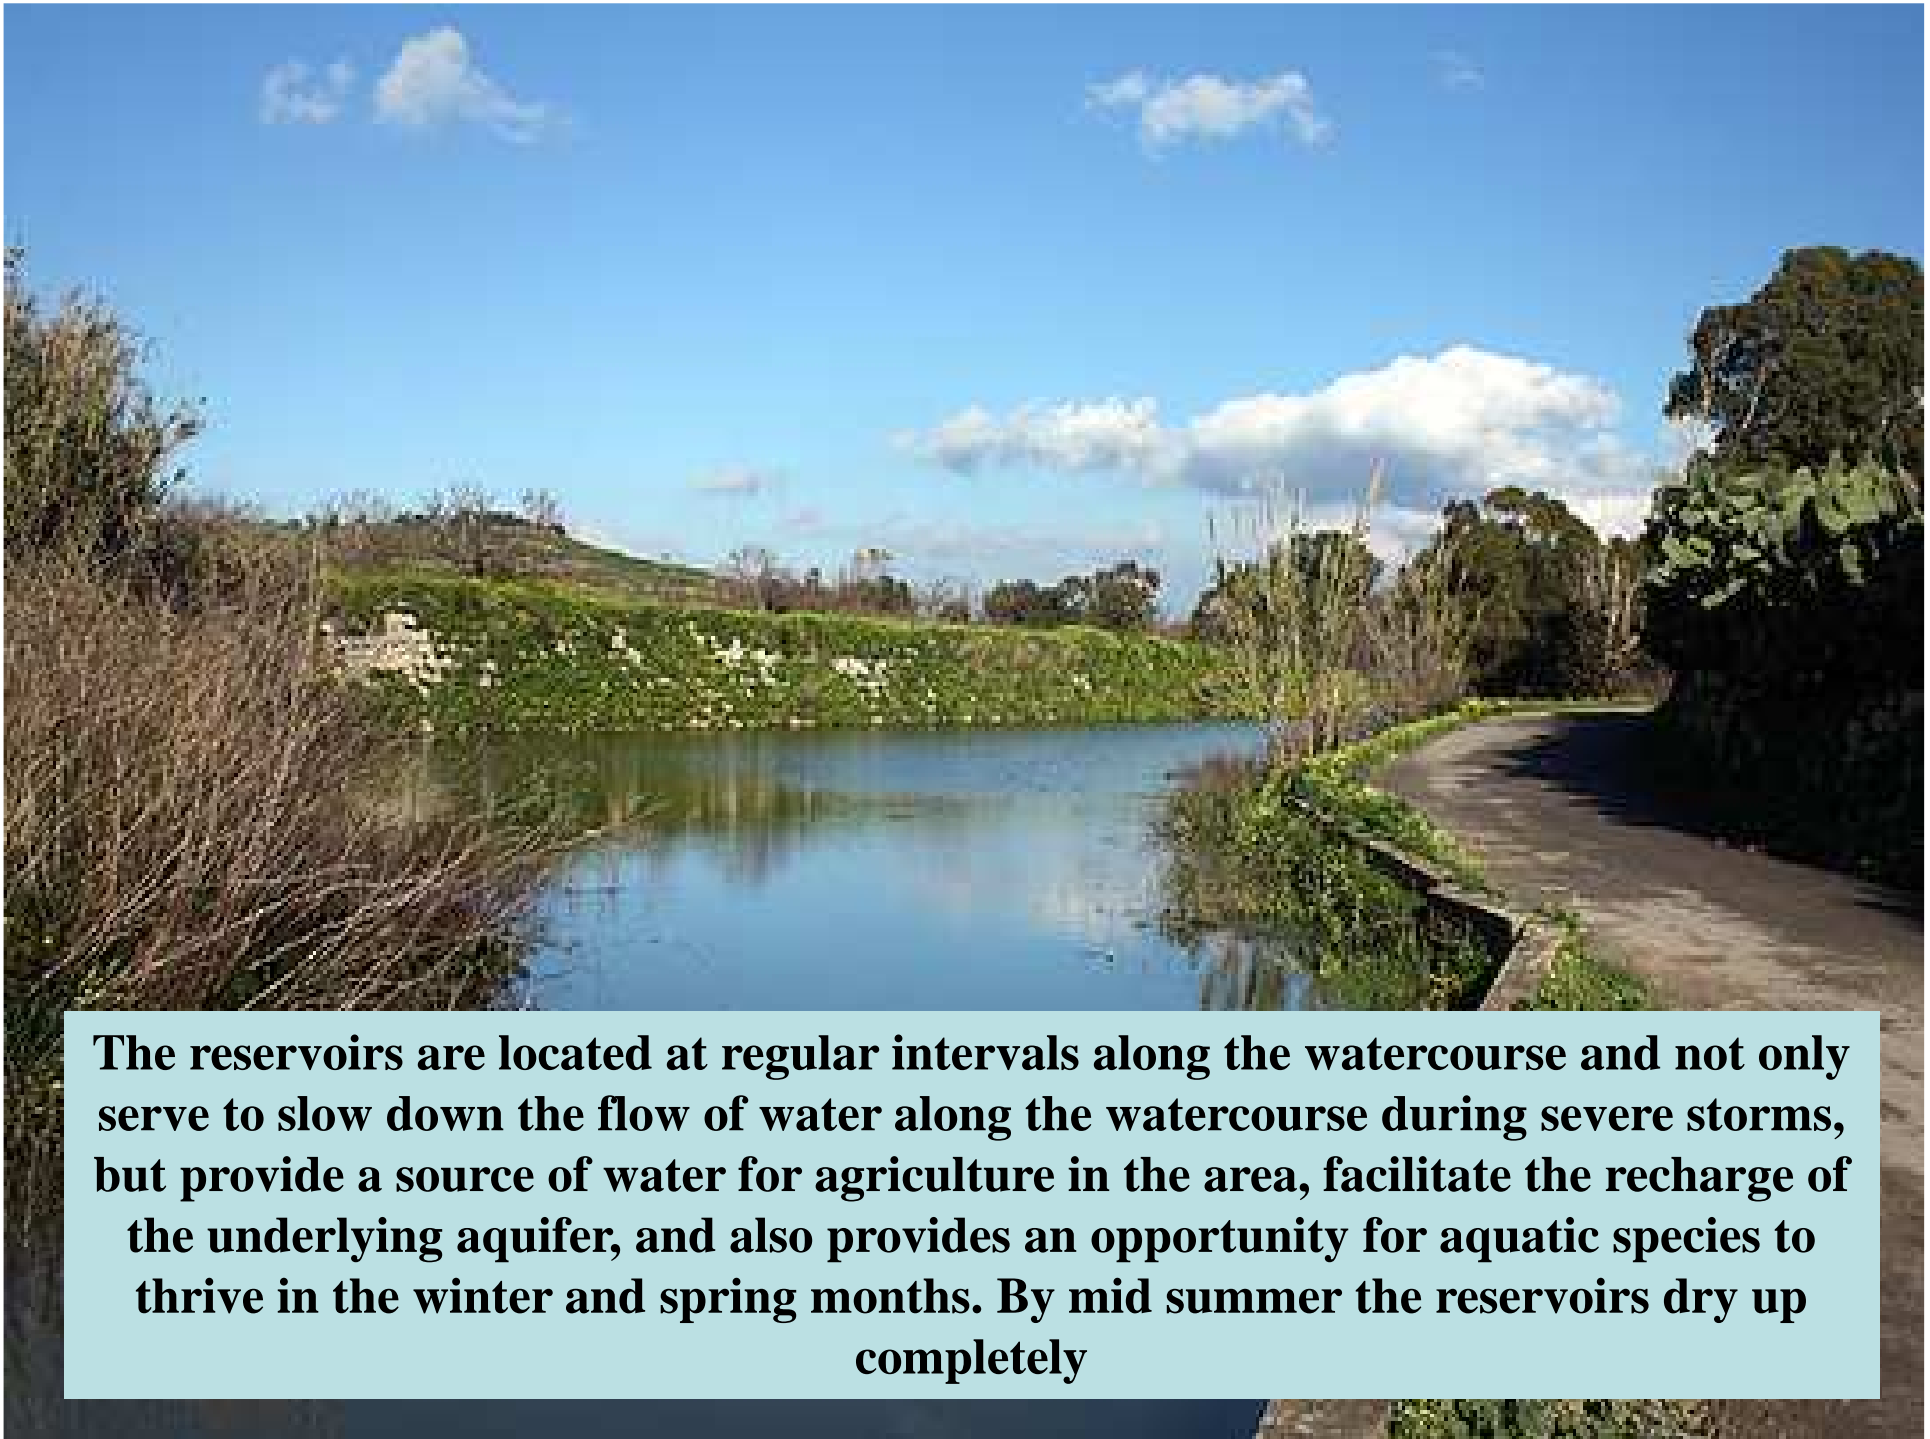
The area features a number of reservoirs built in the 19th century by the British engineer Sir. Osbert Chadwick to trap rainwater for use by farmers in the terraced fields around the valley.

The reservoirs are located at regular intervals along the watercourse and not only serve to slow down the flow of water along the watercourse during severe storms, but provide a source of water for agriculture in the area, facilitate the recharge of the underlying aquifer, and also provides an opportunity for aquatic species to thrive in the winter and spring months. By mid summer the reservoirs dry up completely

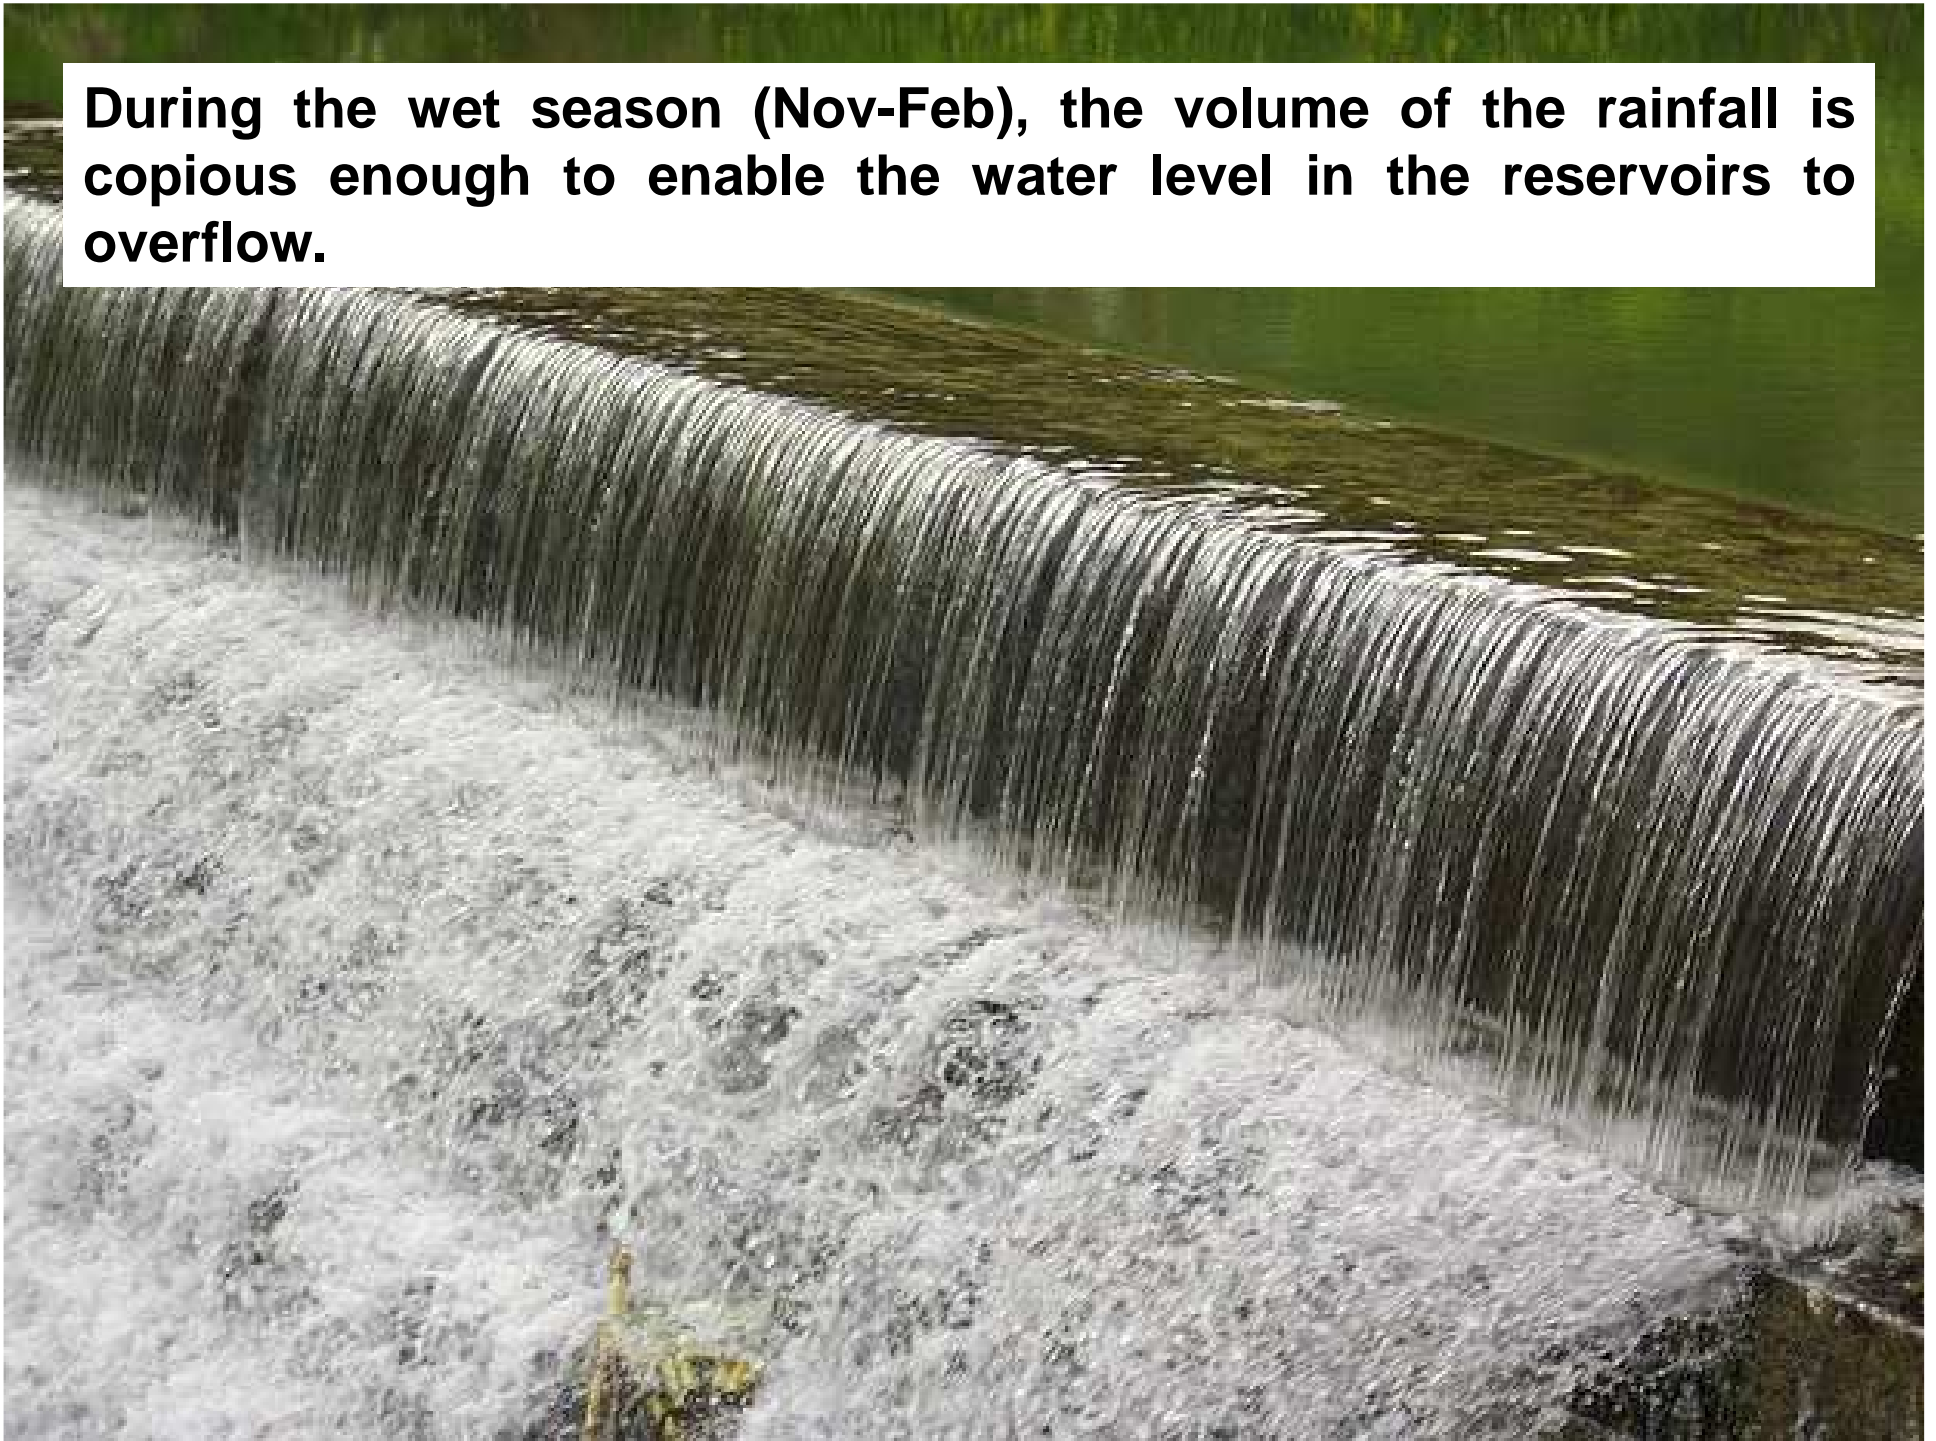
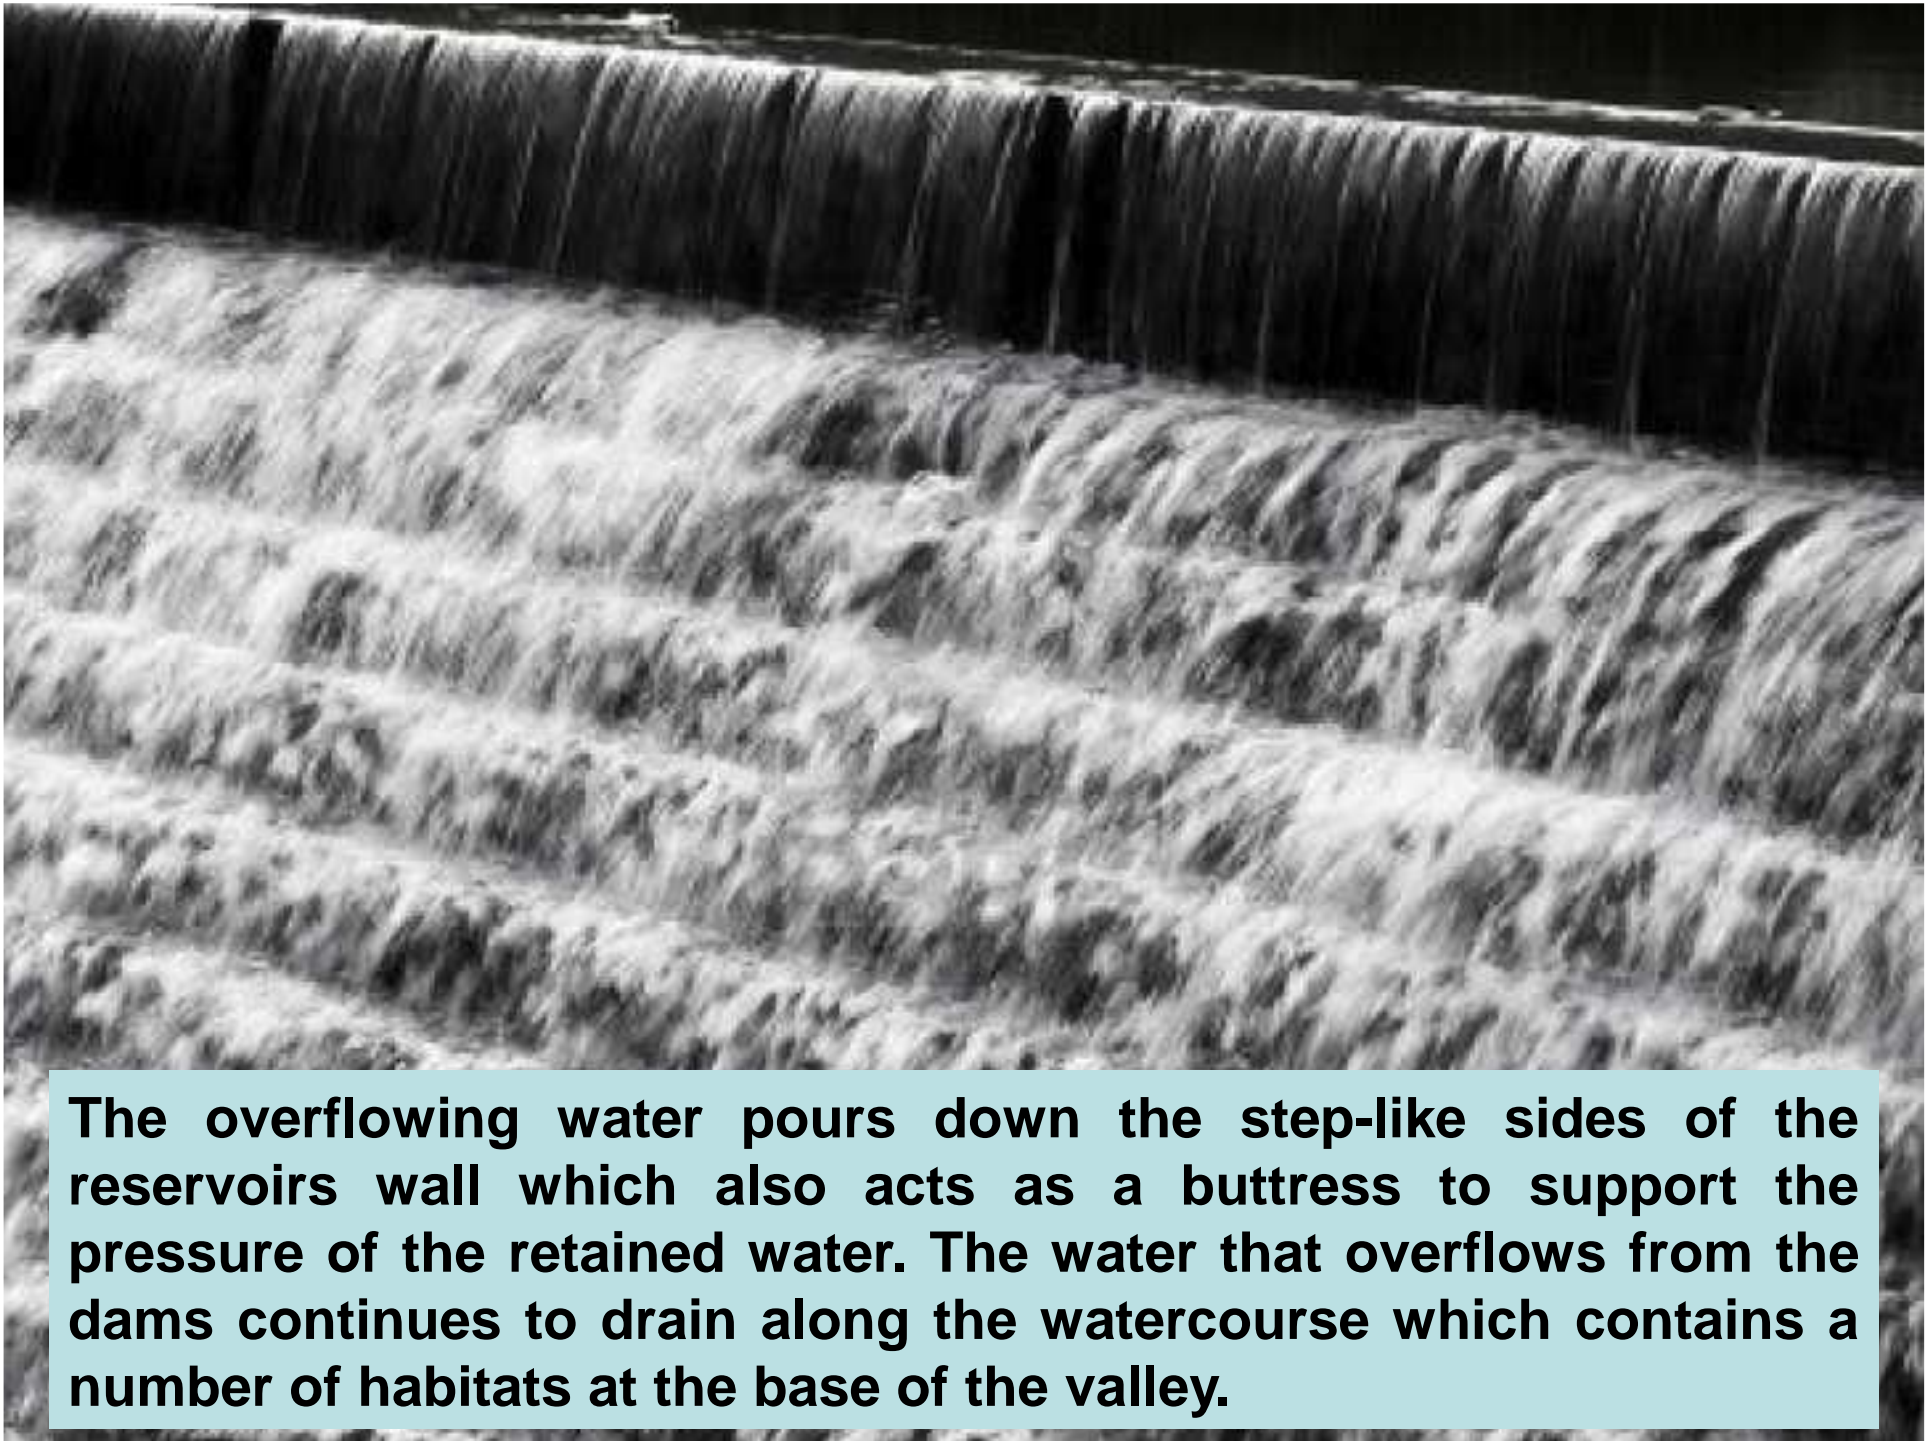
During the wet season (Nov-Feb), the volume of the rainfall is copious enough to enable the water level in the reservoirs to overflow.

The overflowing water pours down the step-like sides of the reservoirs wall which also acts as a buttress to support the pressure of the retained water. The water that overflows from the dams continues to drain along the watercourse which contains a number of habitats at the base of the valley.

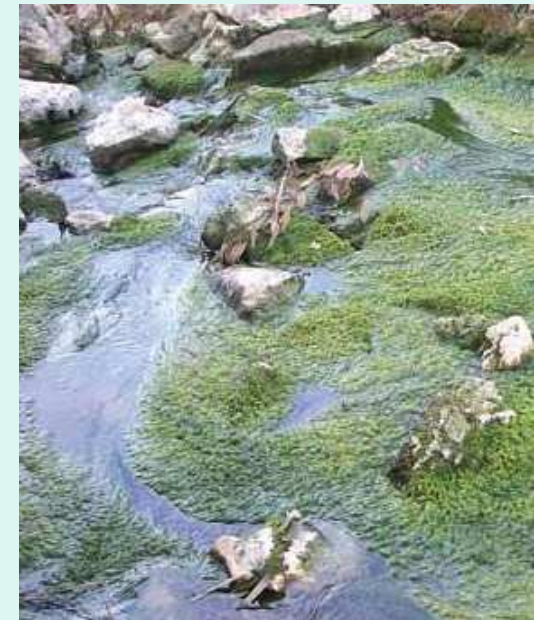
1. Algae/Nitrates

A viscous green soup of algae, which is stifling freshwater life in the area has often been observed. This is the result of uncontrolled use of fertilizers in the surrounding fields, which is in turn fuelling the algal growth. One can only imagine the voluminous quantities of nitrates creeping from these fields and seeping into our aquifers after heavy rainfall. It is being proposed in future policies that farmers use man-made manure as fertilizers.

The Chadwick Lakes overlie the single most important aquifer in the Maltese Islands, the Mean Sea Level Aquifer of Malta. For a number of years now, the nitrate concentration of groundwater pumped from this aquifer, used for the public potable water supply, has exceeded the safe threshold and the concentration is increasing.

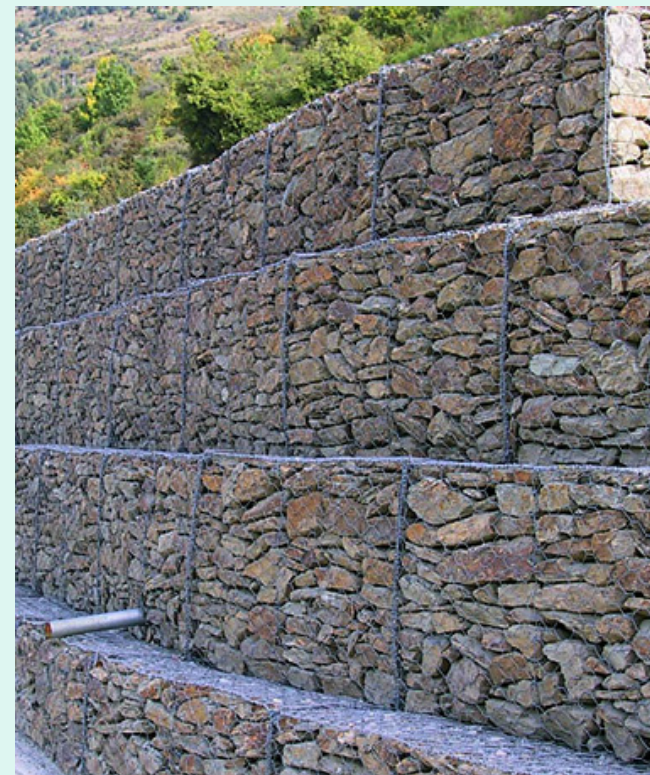
4. Box Gabions Technology

In 1996, field retaining walls were strengthened with box gabions, which look like metal mesh cages. These were built along some of the valley's periphery to avoid soil erosion and allow water through without collapsing. Flora and fauna were also allowed to flourish as they could live between stones. This project was unfortunately stopped in 1998 due to change of environmental political priorities.
